Drivetrain - Angle Gear Fluid Leakage

NO: 46-13

DATE: 4-18-2008

5 cylinder Angle [gear](#) leakage and resealing

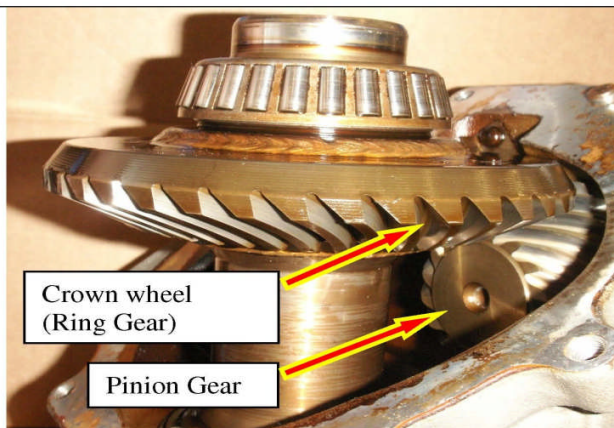
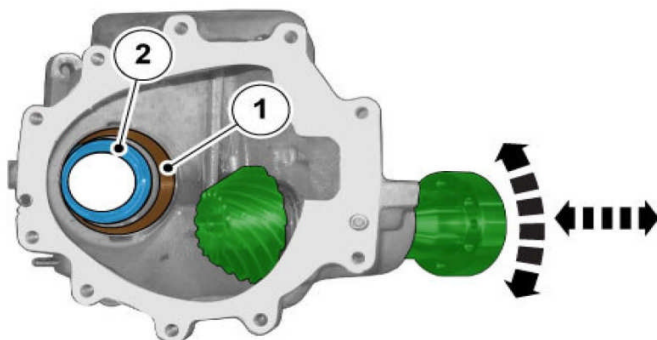
Check the [pinion gear](#) and crown wheel teeth for abnormal wear or damage. Check pinion shaft for axial play or any kind of binding. Check the bearing races (1) in both halves of the [angle gear](#).

If a bearing race is damaged the pinion shaft has play, there is abnormal [gear](#) wear, or if there is any kind of binding, replace the angle gear.

If OK, remove the left side crown wheel shaft seal (2) according to VIDA under sealing ring, crown wheel shaft, left-hand side, replace and continue with the Step 6 of the resealing method.
