**A/T - 2-3 Upshift Flare/Harshness**

NO: 43-37

MODEL: MY 2001-2002 S60, V70, V70 XC

SUBJECT: Shift Quality Issues due to B4 Servo Cover Failure, 2-3 upshift harshness or flare

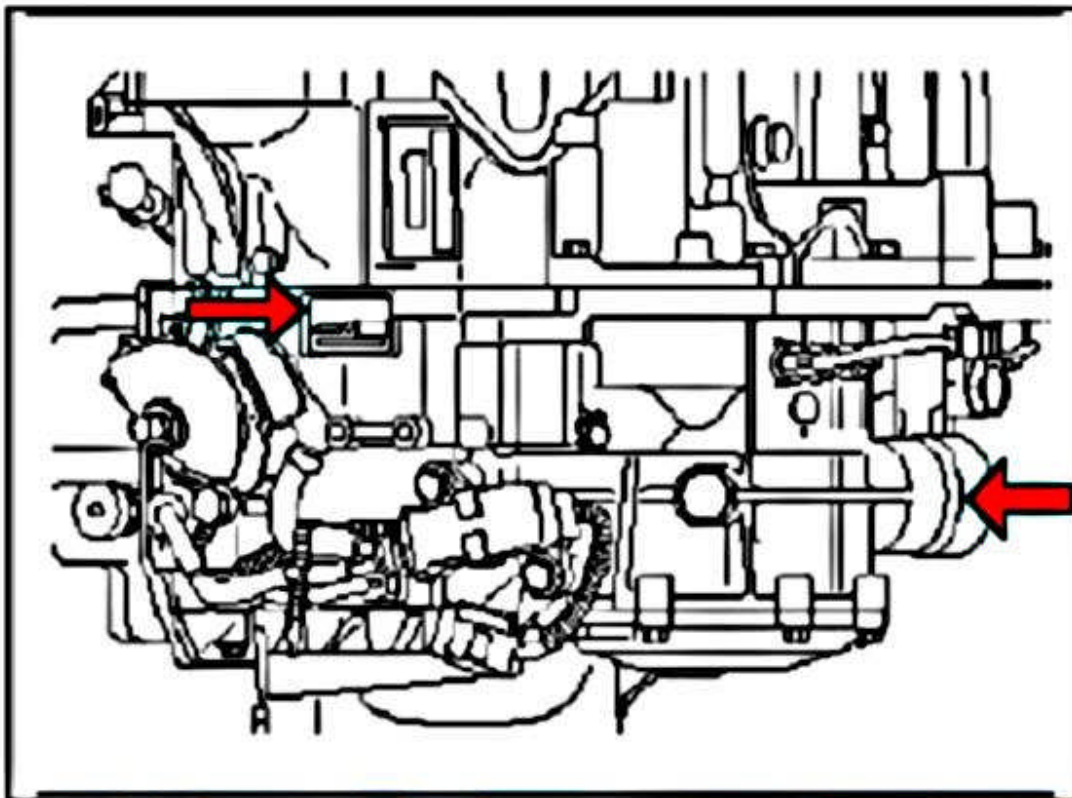
This is a top view of the transmission, as seen from under the hood. The B4 cover is located on the rear of the transmission. It faces towards the rear of the car.

The B4 cover and the identification plate, which contains the serial number are highlighted in this drawing.

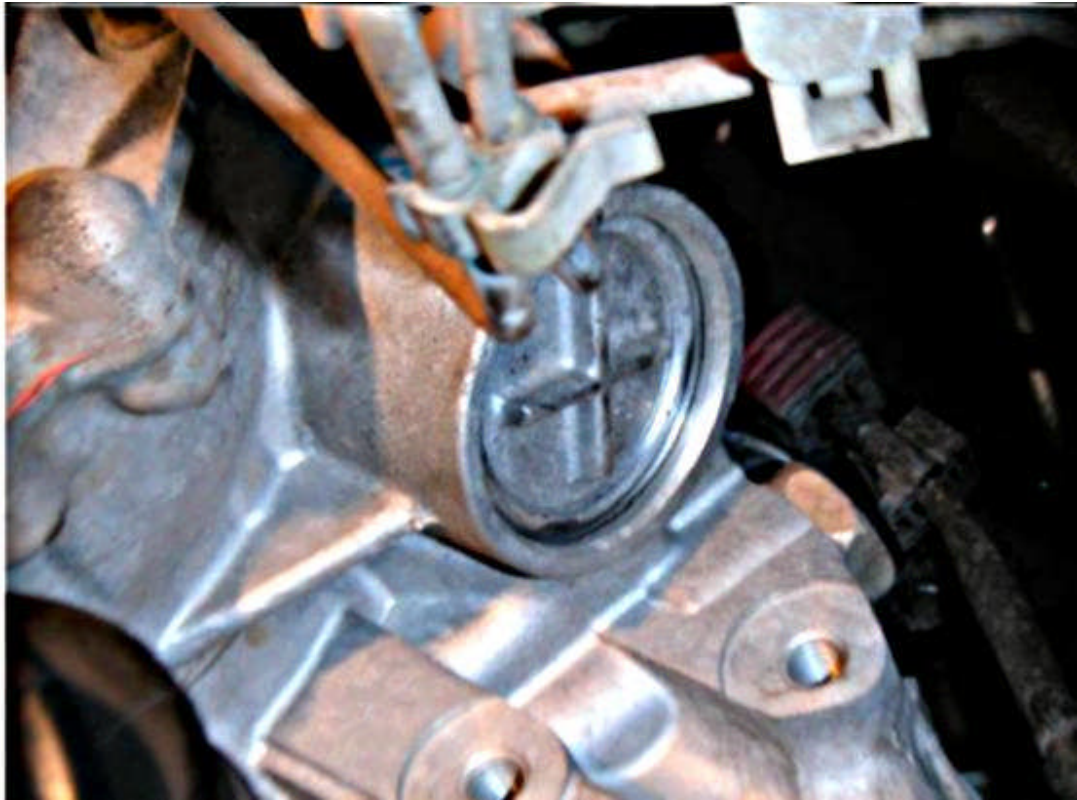
The cover is a tight fit, so it will usually stay in the transmission even after the snap-ring has been removed.

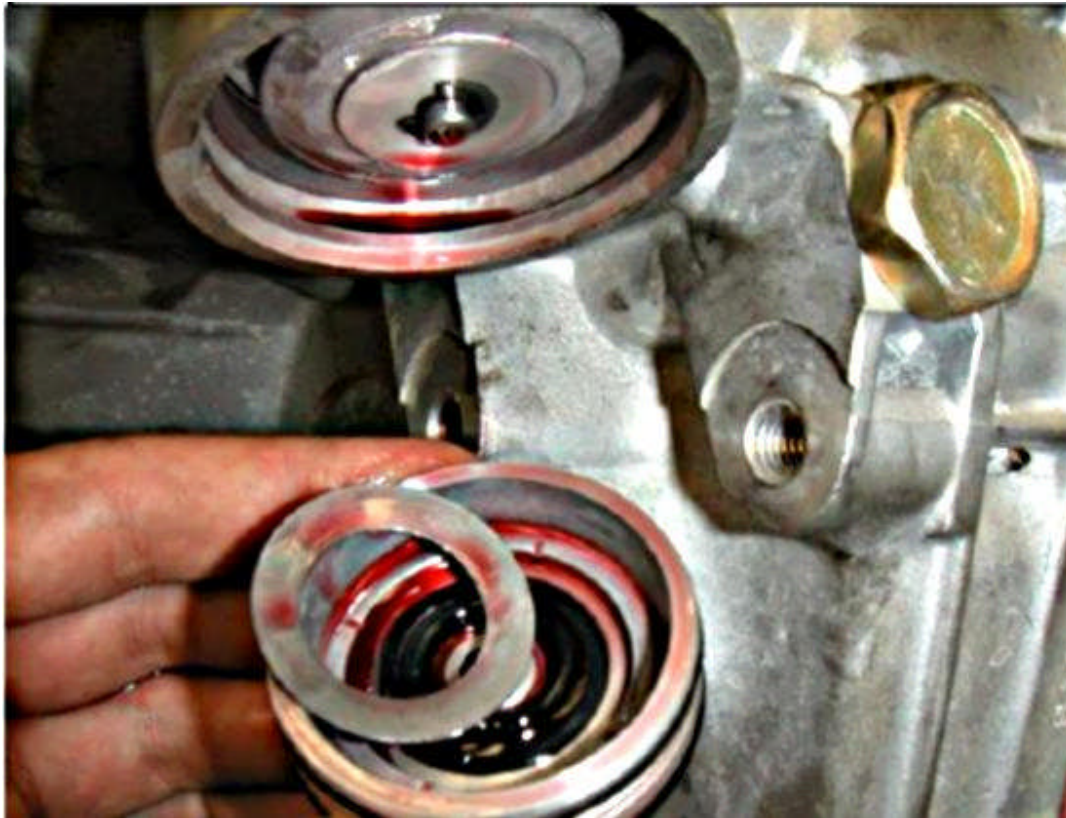
If this washer breaks free from the crimps it will become concaved because of the B4 piston return spring pressure.

Remove the servo cover from the transmission. If it is faulty, it will look like the one pictured here. The steel washer will have become separated from the aluminum cover. As pictured here, the piston and spring will usually stay inside the transmission. If the piston begins to slide out, push it back in and it will usually stay in place.

**NOTE:** If the steel washer is still firmly attached to the aluminum cover, re-install it according to the rest of the procedure, it is not the cause of the harshness / flare.

Replacing the broken B4 cover with a new one (PN 30651771) will remedy these symptoms.
