Repairing a Loose Headlight Reflector Volvo V70XC 2001 – 200? – Mark Pilant

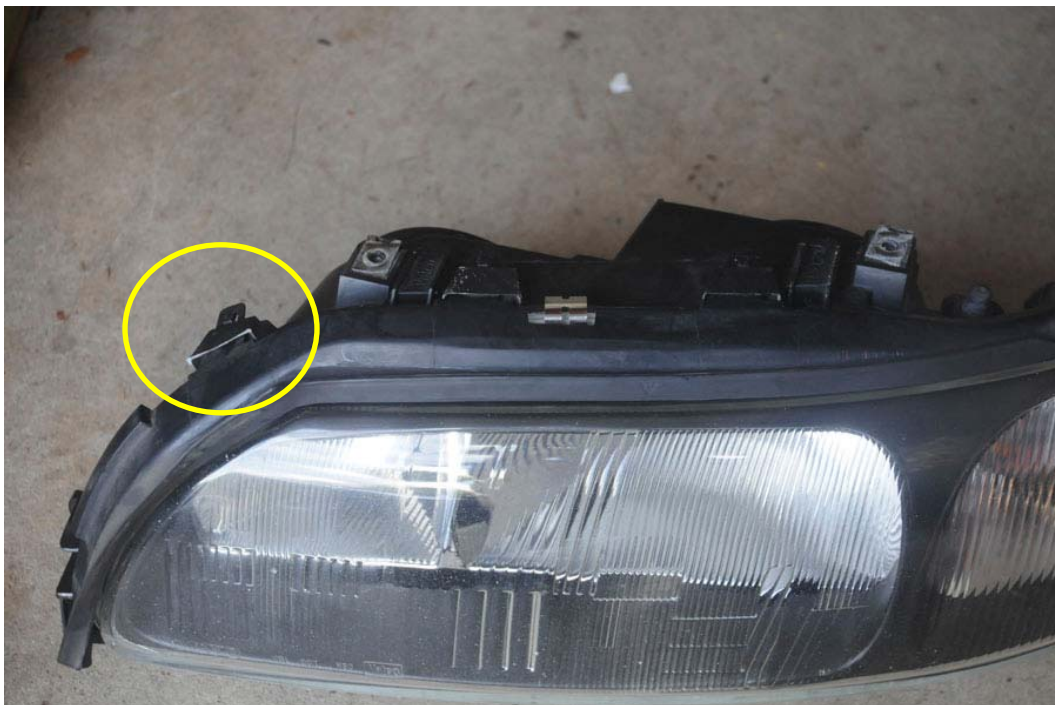
Once you have the headlight assembly out and in your hands, you will need to remove the weather seal along the upper edge. This is done by pressing down on the plastic "spring" tab in the center of each retainer to release the retainer. Below is a partial picture:

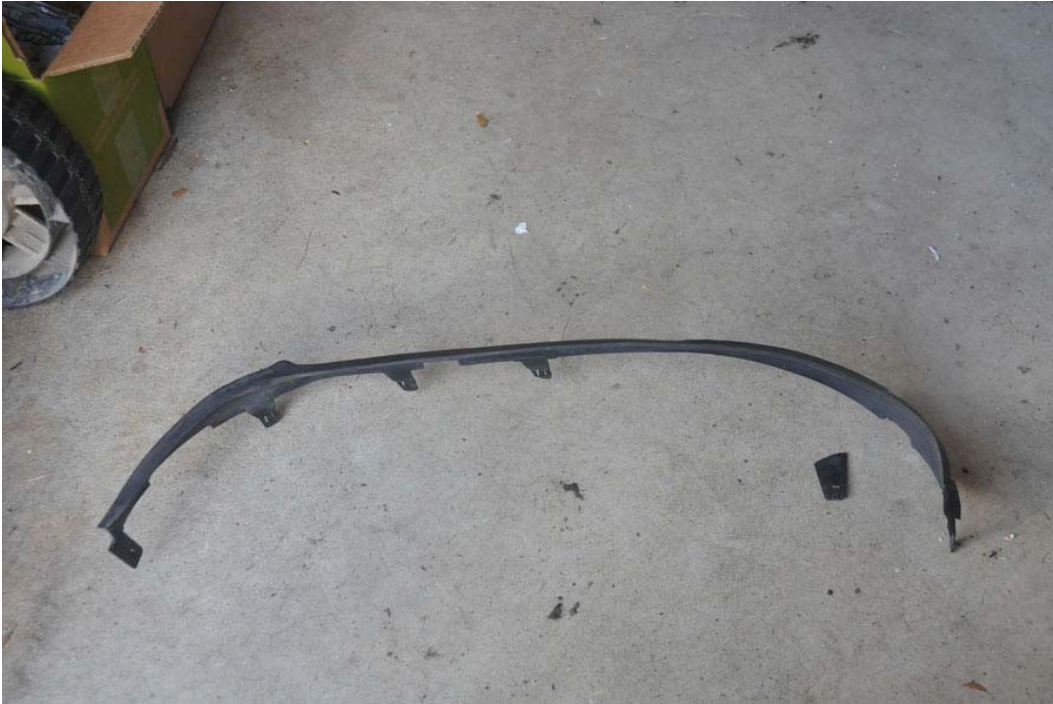
Here is what it looks like when it is removed. Oh yes, be a bit careful removing the retainers and flexing the weather seal. I broke one of the retainers. Oops...

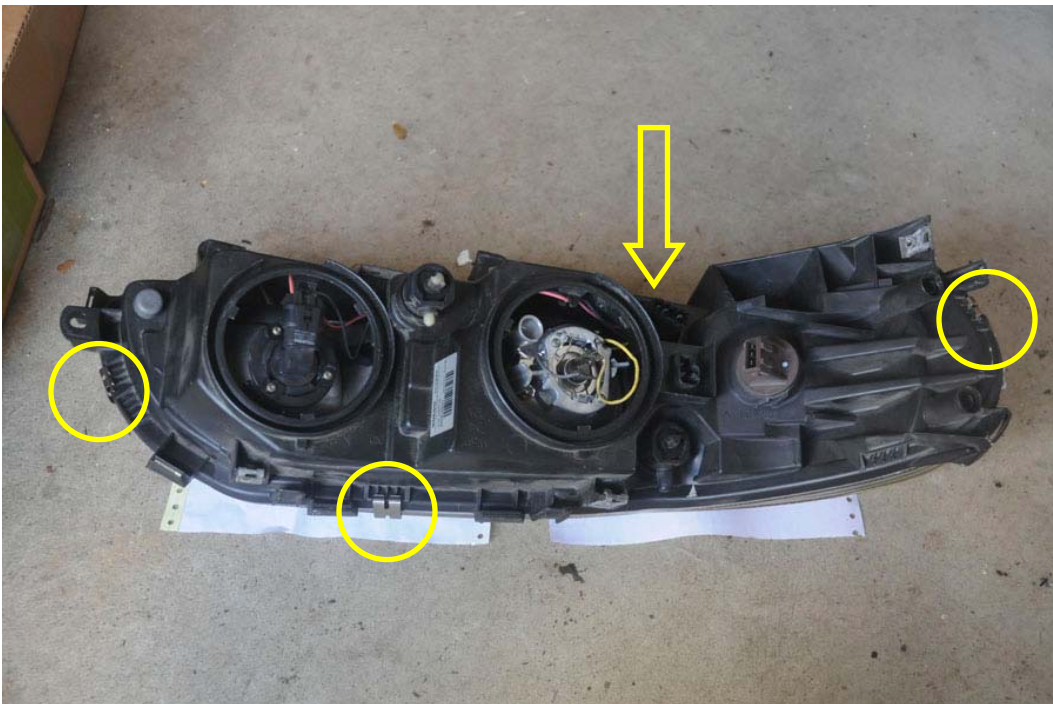
The next step is to remove the lens from the headlight assembly. The first step is to remove the four retaining clips with a small screwdriver or needle-nose pliers. Refer to the picture below:

Once the clips have been removed, you will need to free the lens from the back of the assembly. On the assembly I had, the lens was attached with a non-hardening (waterproof) adhesive in addition to the clips. I ran a sharp knife all around the lens to start to break the seal. Then I took a gasket scraper with a 1" (25cm) blade to **CAREFULLY** and **SLOWLY** pry the lens from the back. You should use a wide bladed tool to pry so as to distribute the force and not crack the lens. In addition, you will need to work slowly to reduce any impact forces which might also crack the lens. In my case, it took me about 25 minutes to get the lens free.

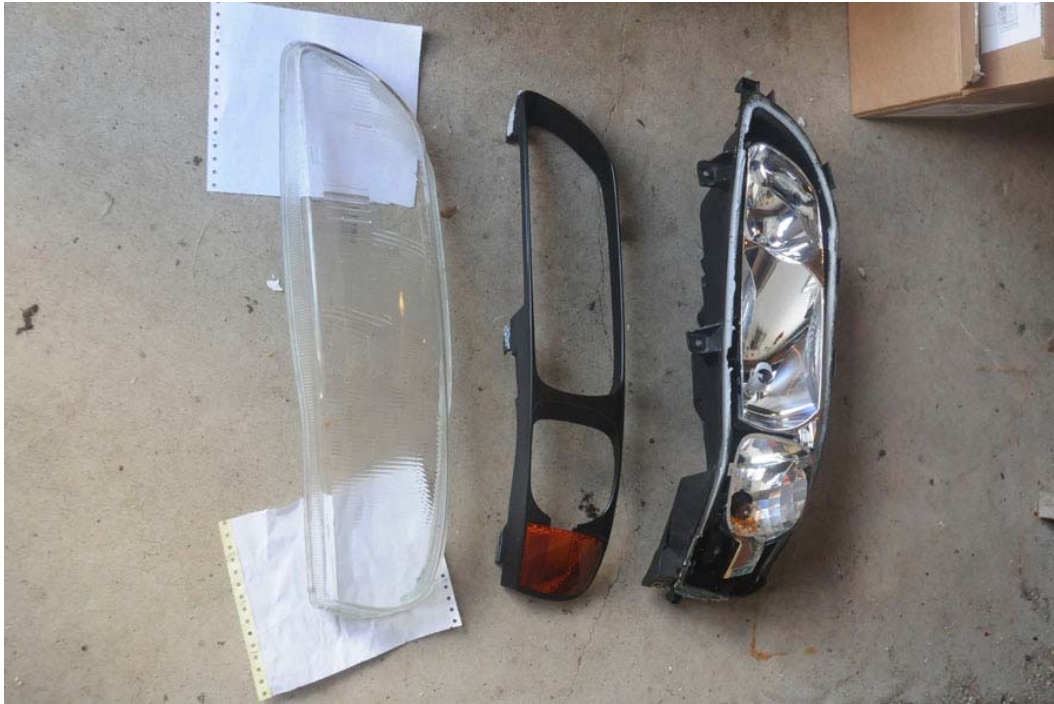
You will now be able to remove the plastic insert to gain access to the reflector:

In the picture above, you can see (left to right) the lens, the plastic spacer, and the reflector and back of the assembly.

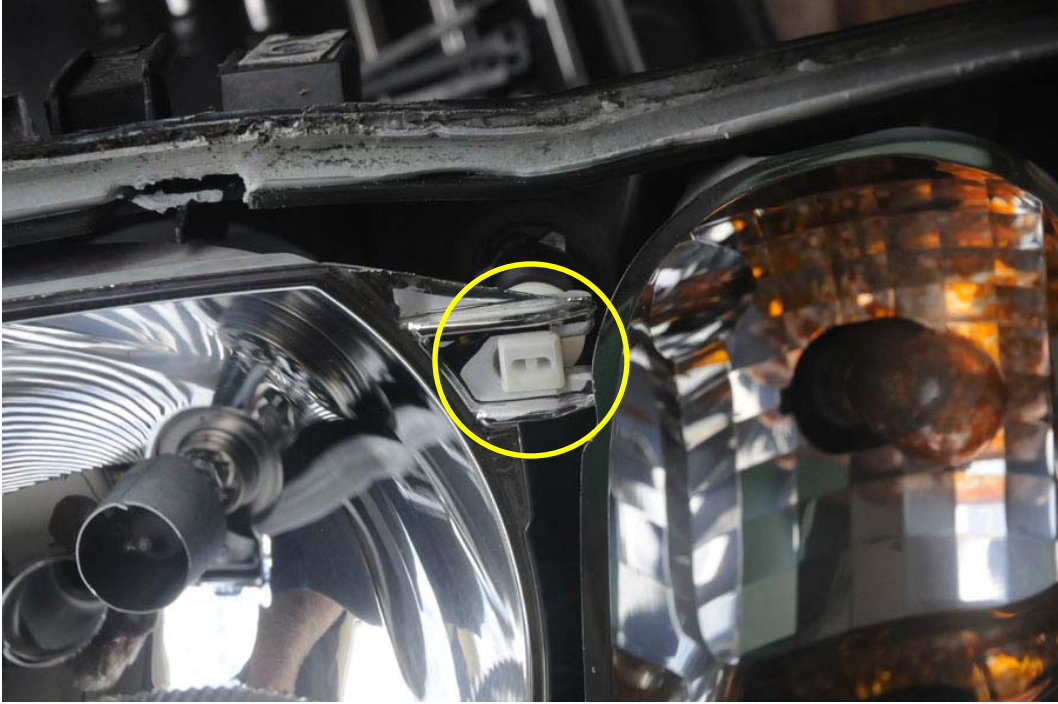
Adjustment of the reflector is done by two adjusters acting with a single pivot point. The horizontal adjuster is located between the high and low beam headlights and the parking/running light. The vertical adjuster is located at the bottom center of the high and low beam headlights. The common pivot is located at the top center of the high and low beam headlights.

Once I had everything apart, I was able to see two problems. First, the high and low beam reflector was not attached to the upper pivot. Second, the vertical adjuster was not attached to the bottom center of the reflector. I was fortunate in that there was no damage to any of the adjusters or the pivot. If you are not so fortunate, you will have to replace the headlight assembly with a new (or used) assembly.

Once the adjusters and the pivot are back into position (see the picture above) reverse the procedure to disable the headlight assembly. Finally, reverse Alan Yeo's headlight replacement to fit the repaired headlight assembly.
