46: Drive shaft, CV joint, B5254T2, AW50/51 AWD

V70 XC (01-) / XC70 (-07), 2005, B5254T2, AW50/51 AWD, L.H.D

Drive shaft right,
replacing
Removal

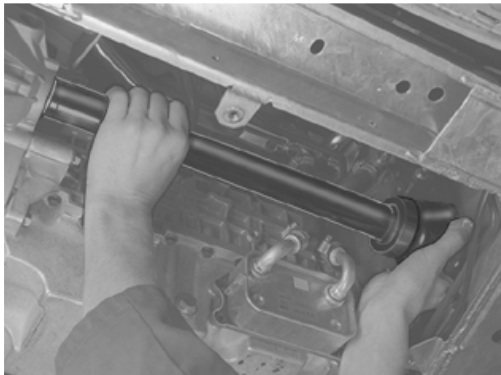
**Remove the drive
shaft from the
gearbox**

Remove:

- the splash guard under the engine. See Transmission oil / oil filter, replacing:Remove the splash guard under the engine
- the cover for the drive shaft pilot bearing.

Pull the drive shaft straight out from the gearbox.

Note! Do not damage the drive shaft when removing it from the transmission.

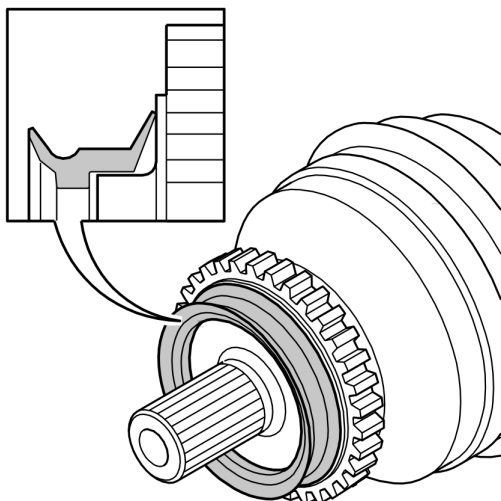
Caution! Later models have a rubber seal on the constant velocity joint. Do not damage the seal. It will be needed for installation.

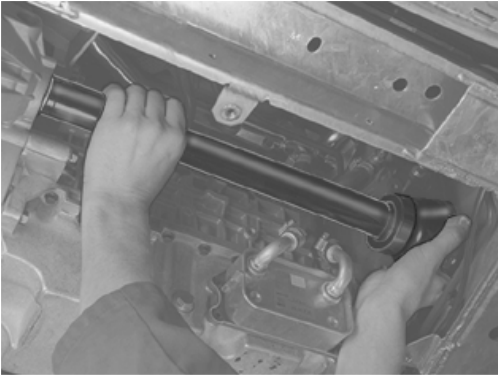
**Install the drive shaft
in the gearbox**

**Note! Do not damage the seal.**

Install **new** cap (steel) for the drive shaft support bearing. Tighten to **25 Nm**.
